LAND SUBSIDENCE AND EARTH-FISSURE HAZARDS NEAR LUKE AIR FORCE BASE, ARIZONA

Herbert H. Schumann (U.S. Geological Survey, Tempe, Arizona)

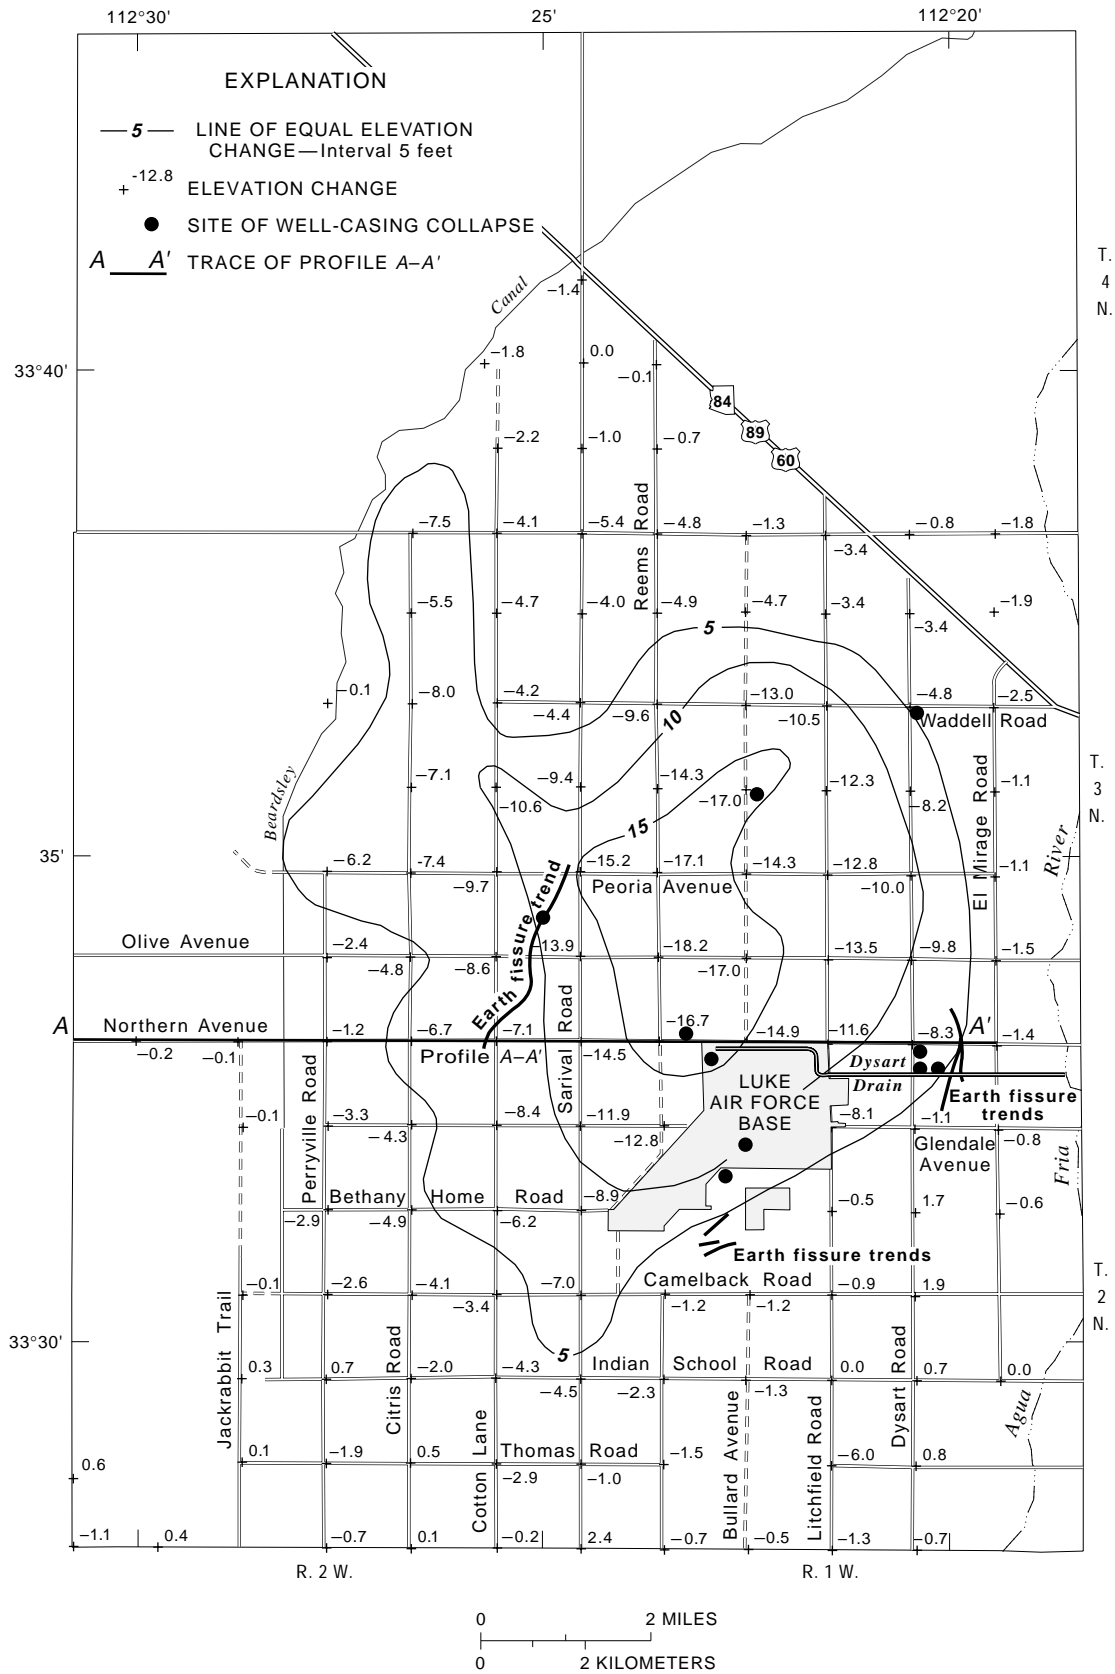
Large-scale pumping of ground water, mainly to irrigate crops in the surrounding area, has caused aquifer hydraulic heads measured in wells to decline more than 300 ft throughout much of the area. Ground-water depletion has caused the aquifer materials to compact and by 1991 had resulted in as much as 18 ft of land subsidence (fig 2). In August 1992, a Global Positioning System (GPS) satellite survey measured more than 17 ft of land subsidence northwest of the base (fig. 3). (See Ikehara #1, #2, and Pool #2 abstracts for GPS applications in land-subsidence investigations). Areas of maximum land subsidence correspond to areas of maximum hydraulic-head decline within the alluvial-aquifer system.

Figure 2. Land subsidence in part of the western Salt River Valley, 1957–1991.

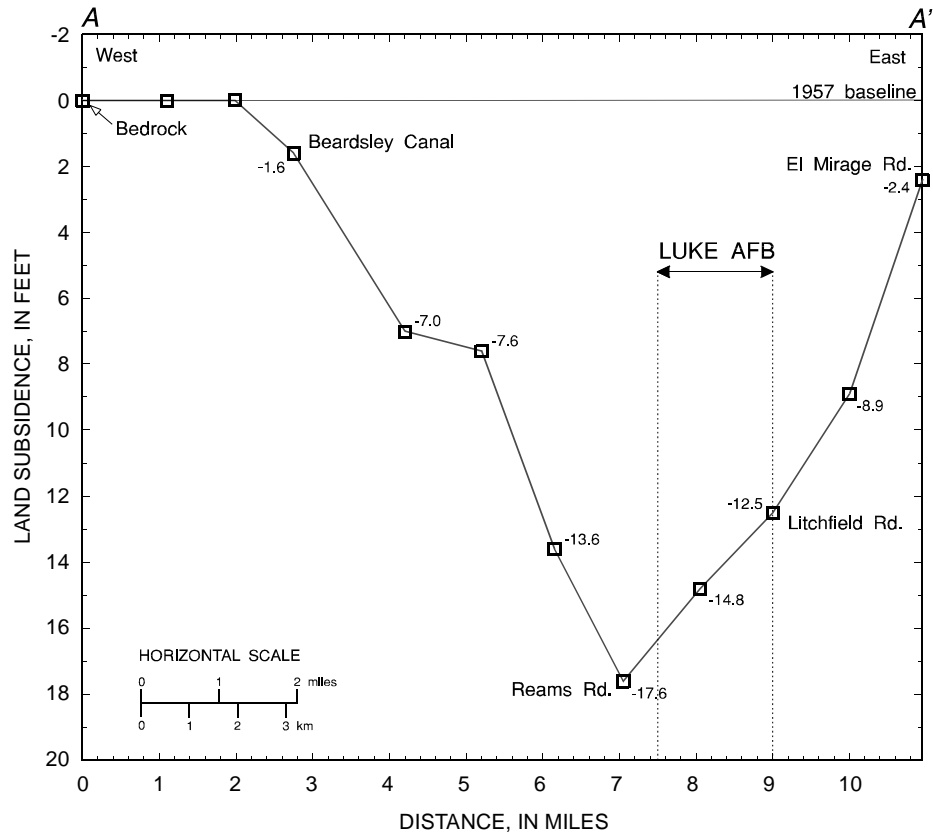
Figure 3. Profile of land subsidence, 1992, along Northern Avenue in the western Salt River Valley, Arizona.
